The Restoration and Conservation of a Gilded Rococo Room

by William B. Adair

Rococo Style II

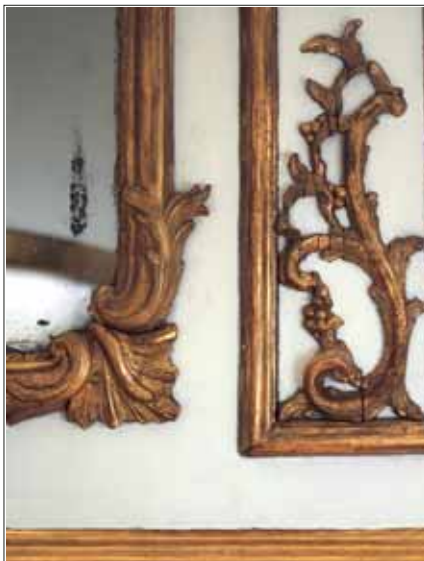
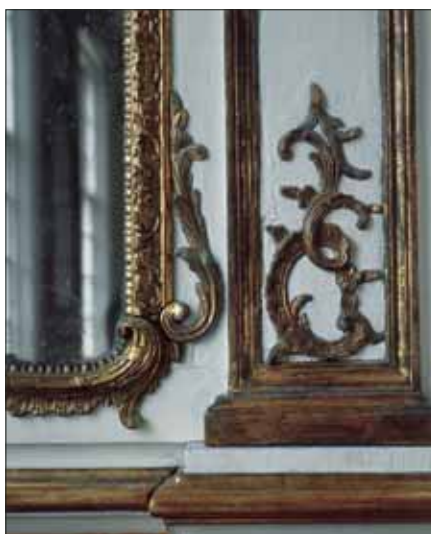
Two dominant styles of Louis XIII and the Regence period co-exist in silent symbiosis within the room as a unified whole. Shown after intense conservation efforts, one contains an intensely deliberate cross-hatched gesso as a background pattern for small "C" scrolls that terminate in a roccaille shell/leaf pattern. The other has a relatively simple ogee molding that still has the flourishing terminal Rococo leafage as counterpoint to the plain moulding.

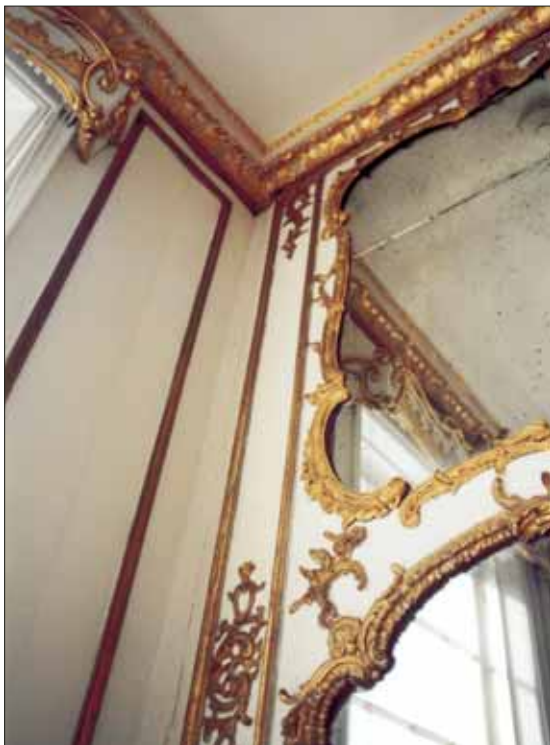
Clockwise from above: This corner of the room shows the many mouldings, mirror frames, and the wainscoting that needed repair. Annie and Francesco Gronchi, who were trained on this extensive project. Some areas has more missing than existing ornamentation.

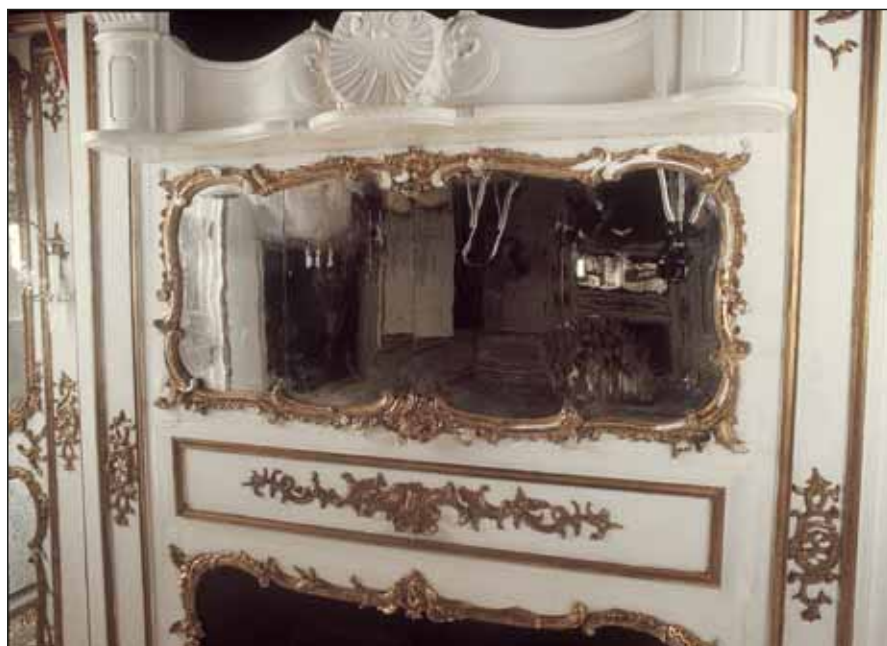
One of the many mirror frames, with white (ungilded) areas showing necessary repairs.
