The Restoration and Conservation of a Gilded Rococo Room

by William B. Adair

Rococo Style II

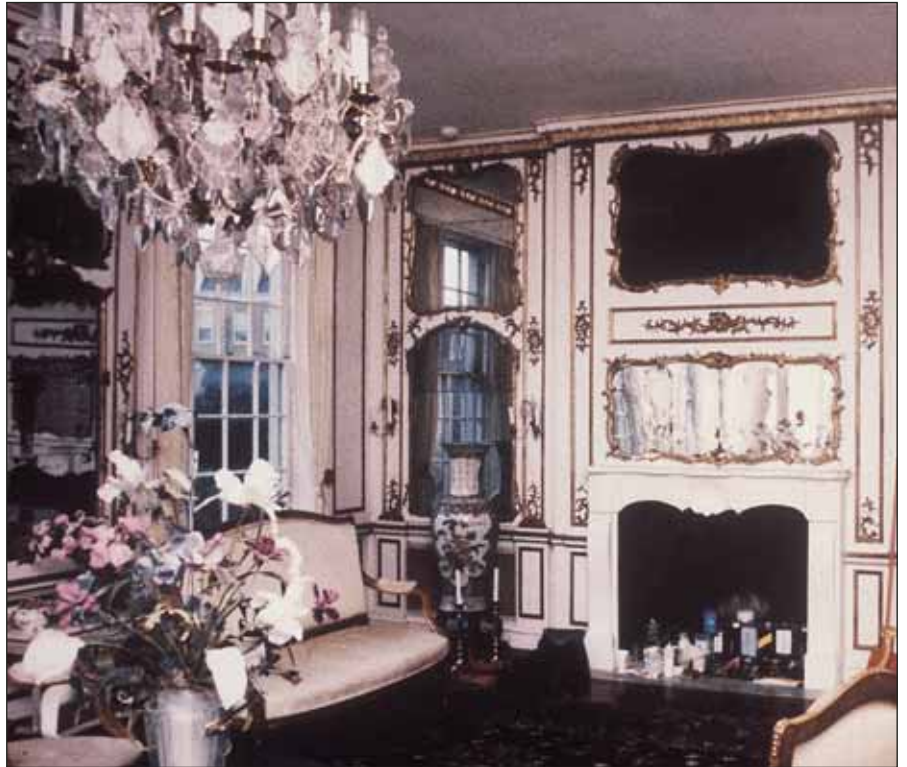
The completed “Salon Room” as it appears today, after a conservation project which took more than two decades to complete.

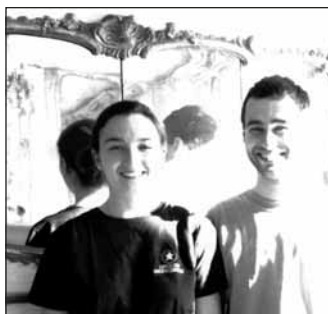
Clockwise from above: This corner of the room shows the many mouldings, mirror frames, and the wainscoting that needed repair. Annie and Francesco Gronchi, who were trained on this extensive project. Some areas has more missing than existing ornamentation.
